ROOF INSPECTION REPORT

6 Kirk Brae, Maybole, KA19 7ER

DW-003-2002

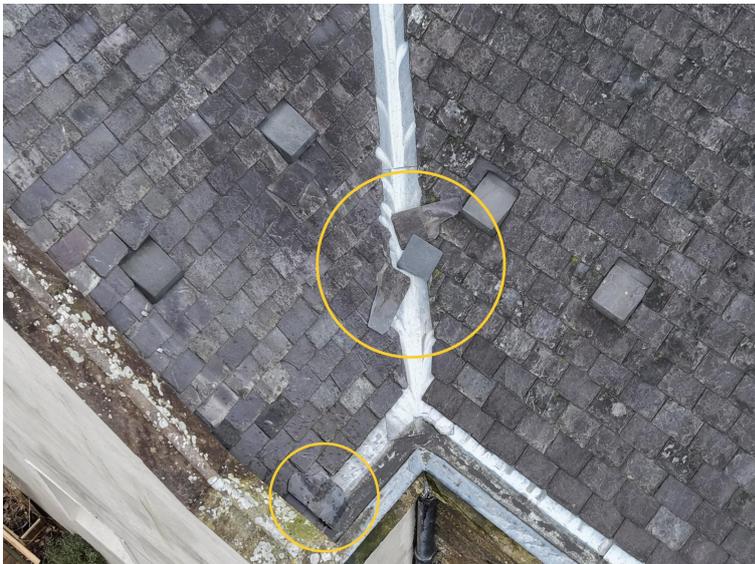
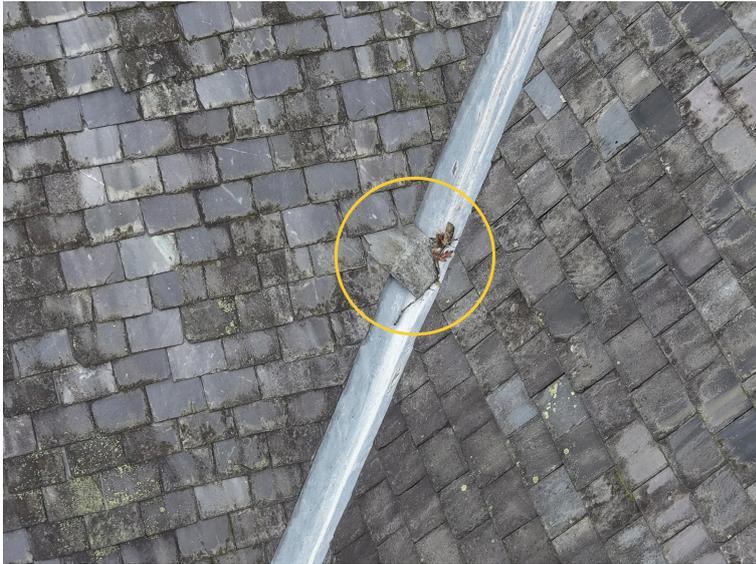
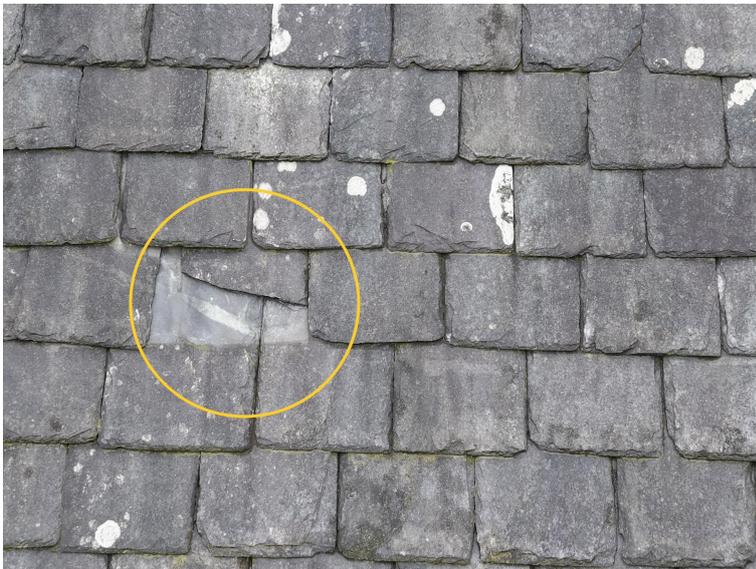
Finding 1 – Displaced Slate Tiles

Multiple slate tiles were identified as displaced from their intended fixing positions across sections of the roof.

Displacement increases the risk of wind-driven rain penetrating beneath the slate covering.

- Fallen slate at valley junction
- Displaced slate tiles

Affected slates should be repositioned or replaced by a qualified roofing contractor. Surrounding fixings should also be inspected.

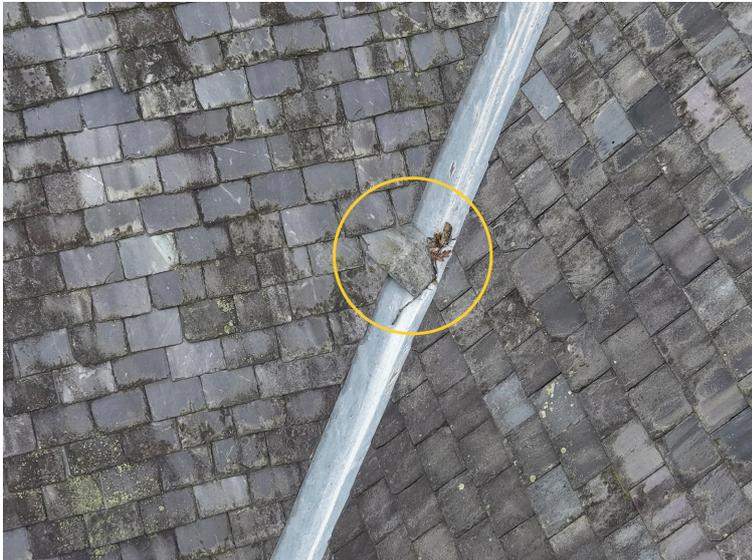
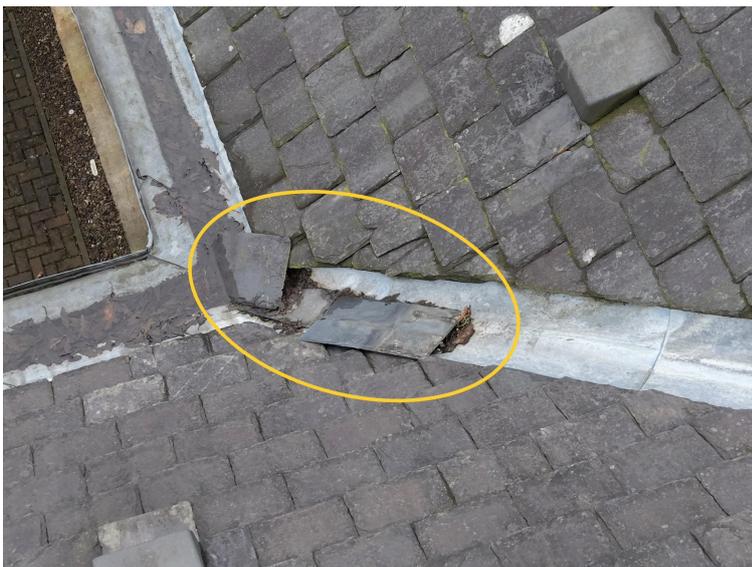
Finding 2 – Fallen Slate at Valley Junction

A slate tile at a valley junction has fallen, exposing the underlying substrate.

This defect presents a direct pathway for water ingress and may result in internal damp penetration if left unresolved.

Prompt repair is recommended to reinstate the roof's weatherproof integrity.

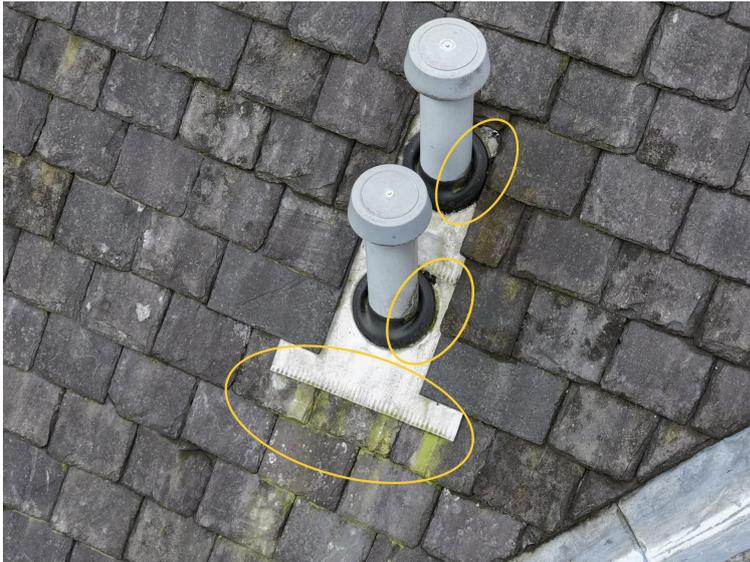
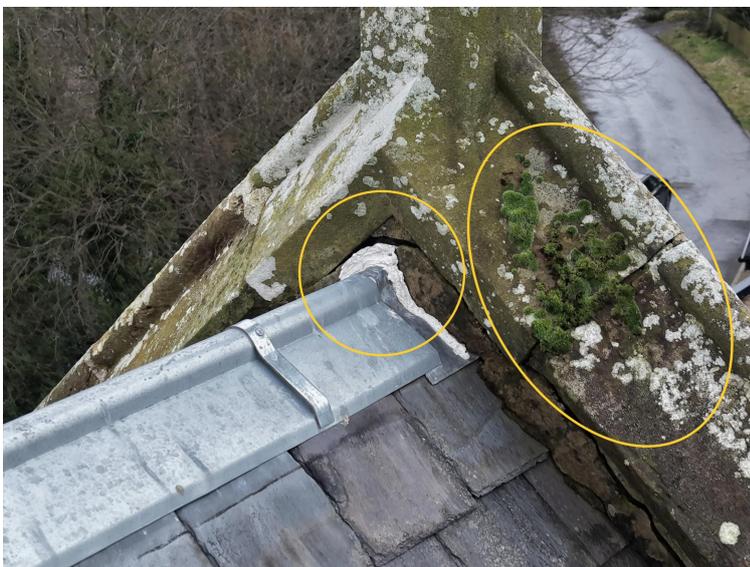
Finding 3 – Moss Accumulation

Moderate moss growth was observed across sections of the slate roof surface, particularly along shaded elevations.

Moss retains moisture against the slate surface and may accelerate deterioration over time.

Professional roof cleaning and preventative maintenance may be considered.

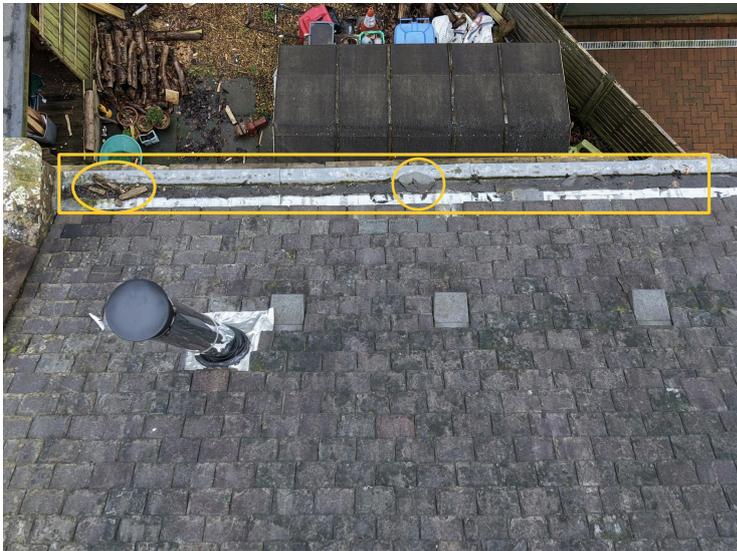
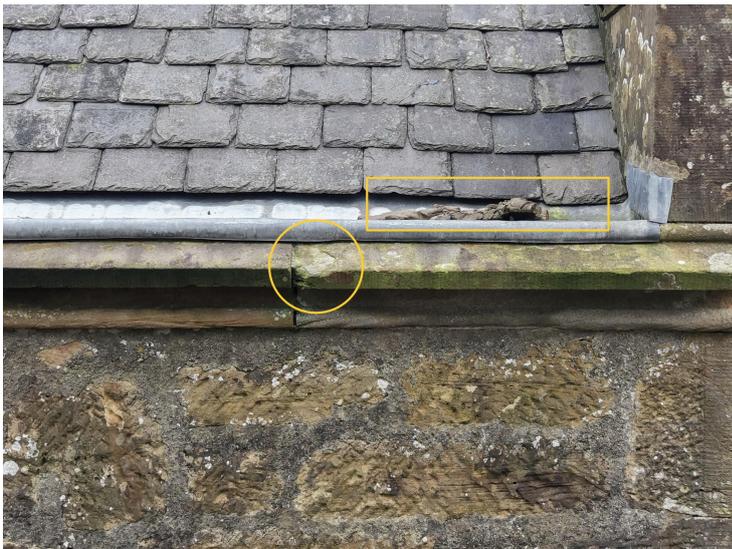
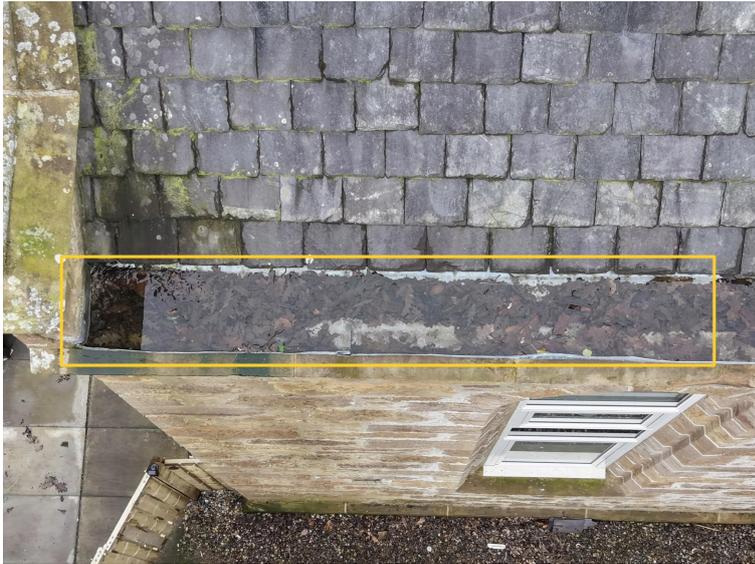
Finding 4 – Gutter Debris Build-Up

Debris accumulation was identified within sections of the guttering system.

Blocked gutters may result in overflow during periods of rainfall, potentially contributing to damp-related issues.

Gutters should be cleared to ensure effective drainage.

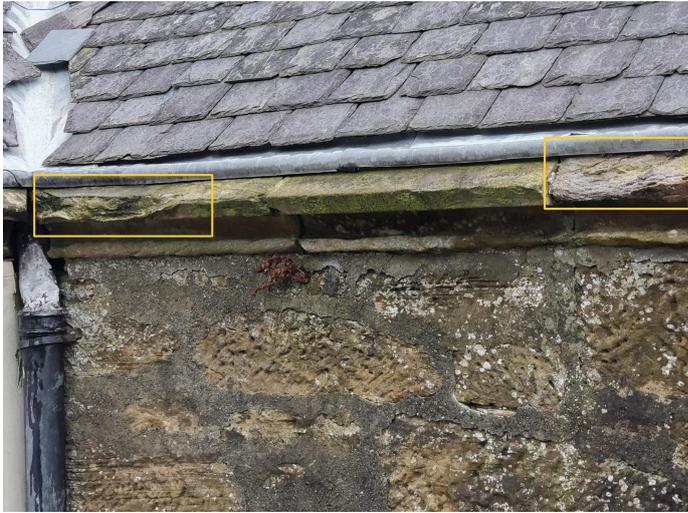
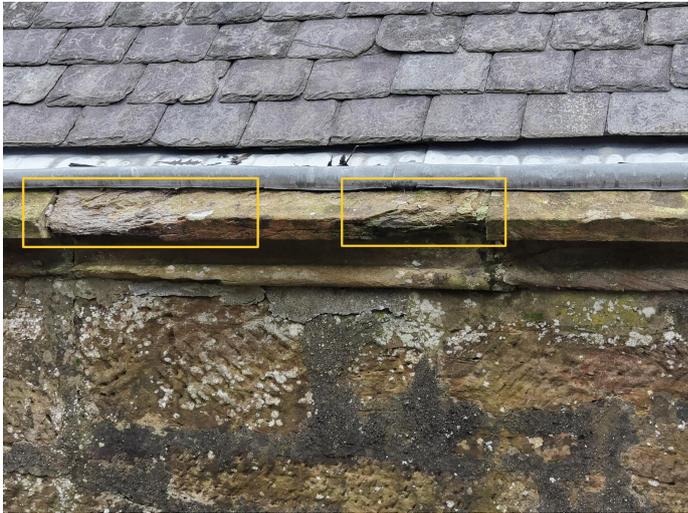
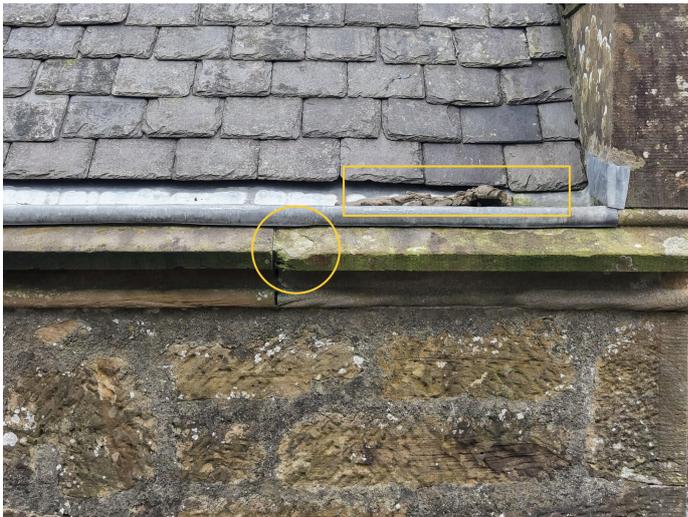
Finding 5 – Upper Stonework Condition

Minor cracking and general weathering consistent with age and environmental exposure was noted to upper stone detailing.

Currently considered low risk; ongoing monitoring is advised.

No immediate action required. Periodic inspection recommended.
