ROOF INSPECTION REPORT

Freedom Fields, Straiton, KA19 7NB

16 February 2026

DW-160226-001

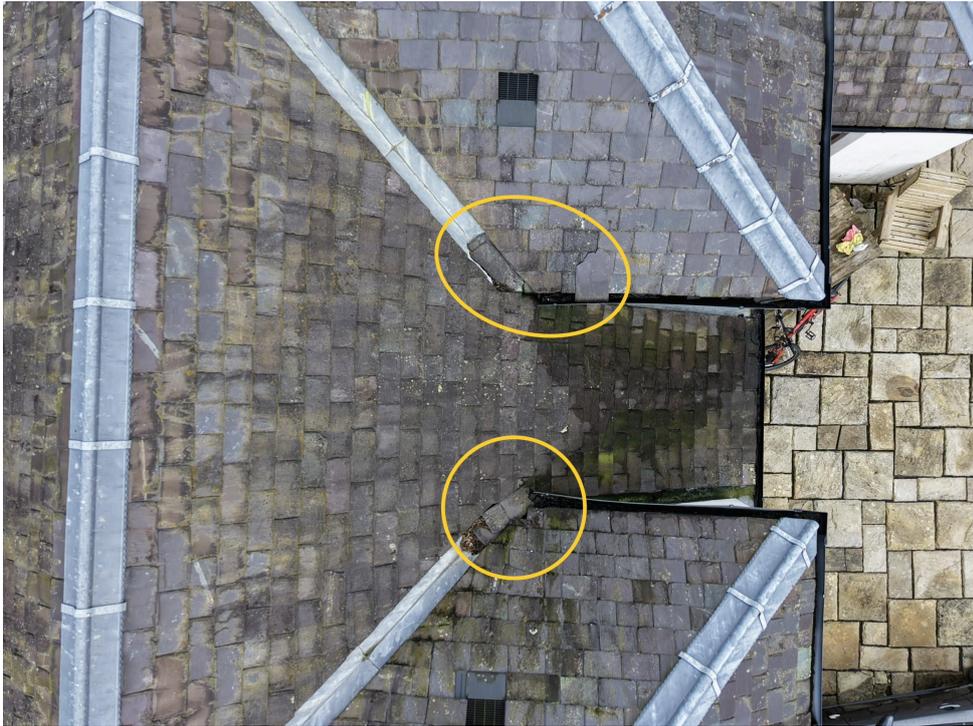
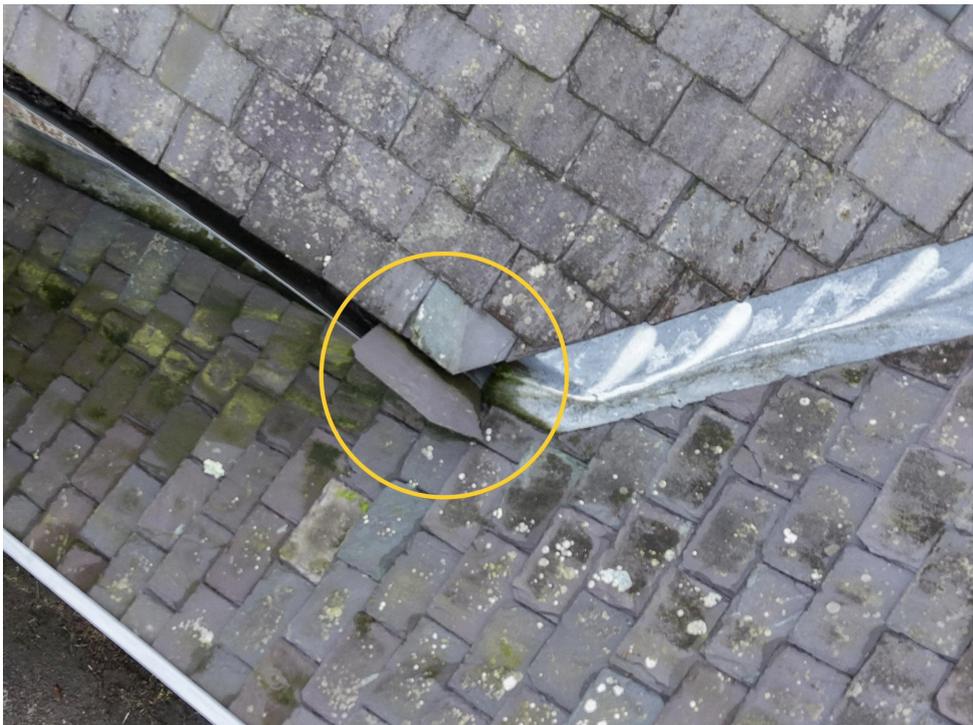
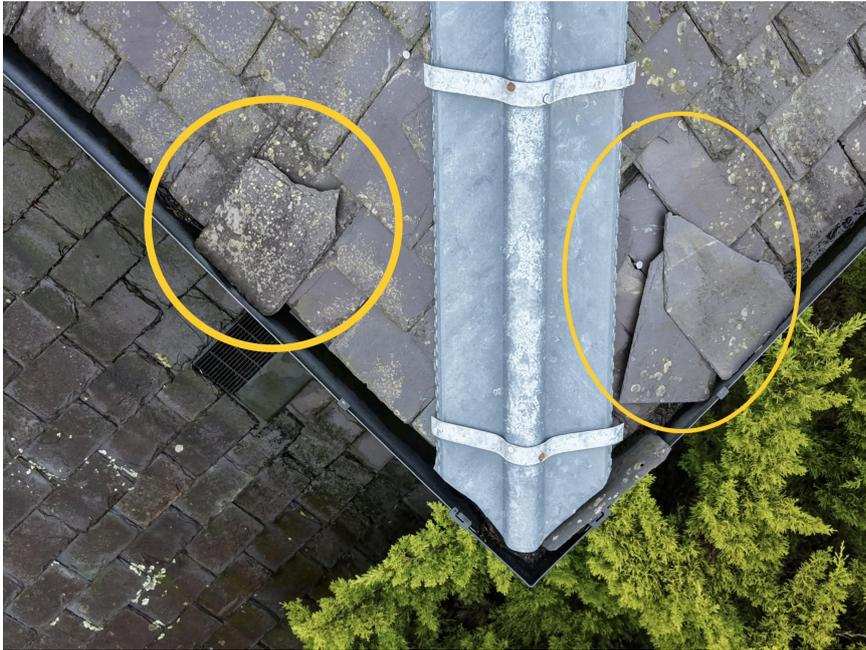
Finding 1 – Missing and Displaced Roof Slates

Multiple tiles were identified as missing from various sections of the roof. Additional slates were observed displaced and resting within the guttering system. Isolated areas show minor misalignment where slates are not seated uniformly.

Missing and displaced slates create gaps in the roof covering and increase the risk of water penetration during adverse weather conditions.

- Missing and displaced roof slates
- Detached metal trim at roof junction

Slates should be replaced or refitted by a qualified roofing contractor. Surrounding fixings should be inspected during remedial works.

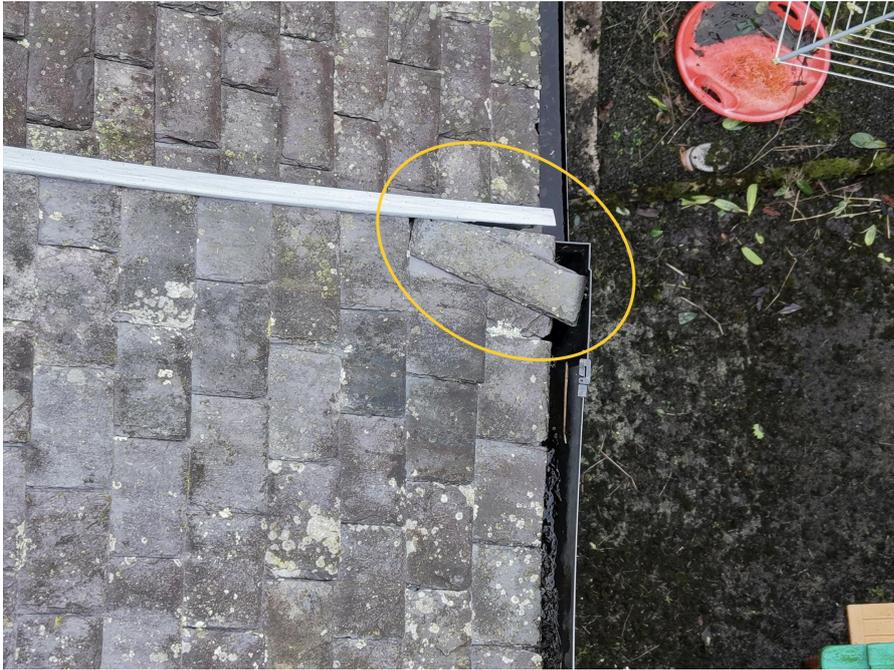
Finding 2 – Detached Metal Trim at Roof Junction

At the junction where the upper kitchen roof meets the lower courtyard roof, the metal trim / flashing detail has become detached and is no longer securely seated along its full length.

This condition presents a potential pathway for water ingress at the junction point.

The detached trim should be securely refixed or replaced to reinstate weatherproof integrity.

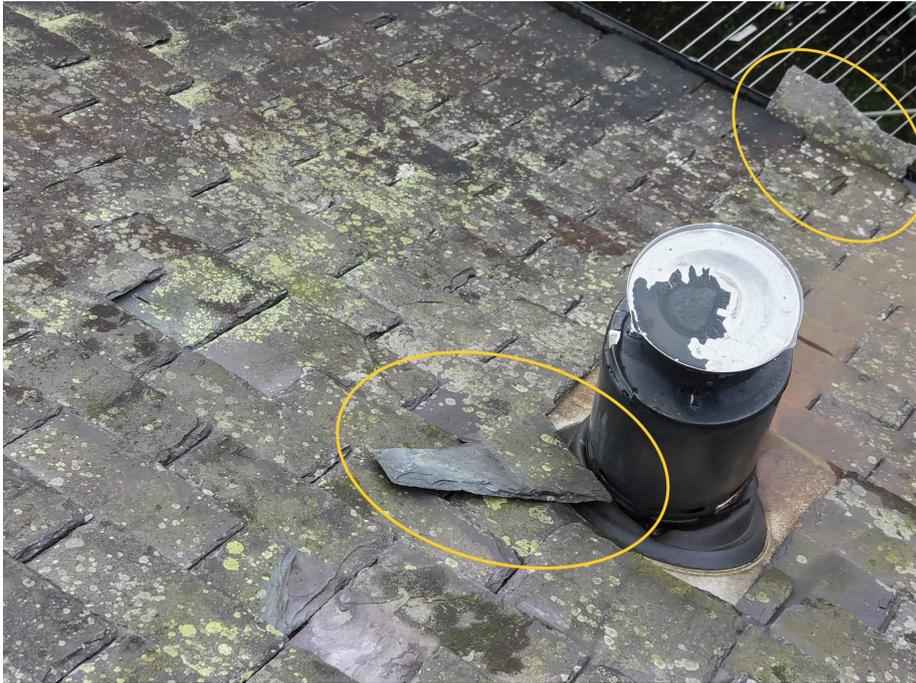
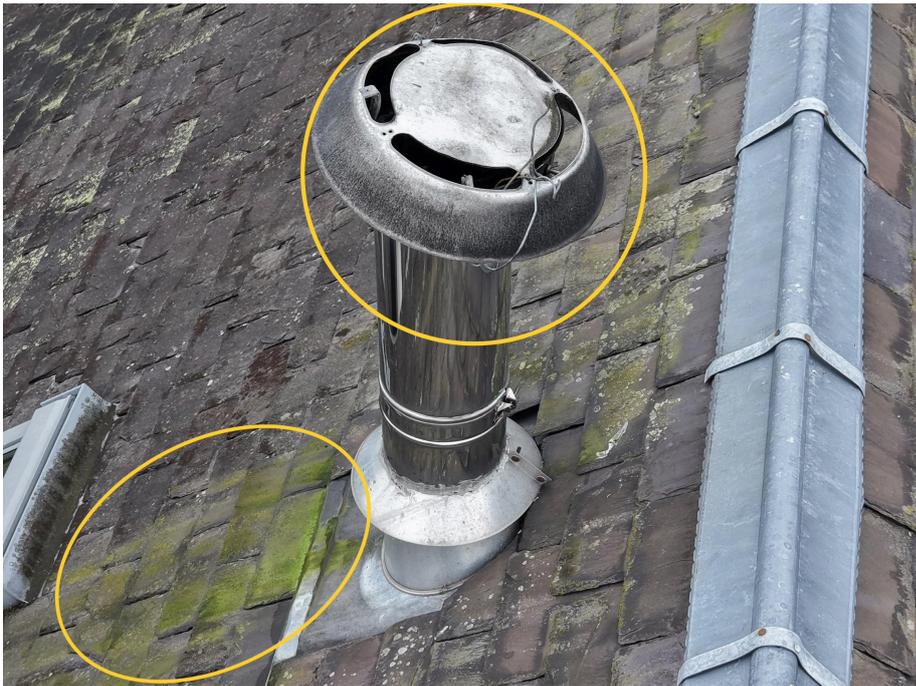
Finding 3 – Chimney Installations

- The log burner chimney rain cap appears misaligned and not centrally seated.
- The boiler flue base seal appears distorted. A roof slate is currently in contact with the base of the flue unit.
- Orange staining is visible beneath the boiler flue, indicating ongoing weathering or runoff.

Distortion and misalignment may compromise effective weather sealing over time.

- Boiler flue base seal distortion
- Log burner chimney rain cap misalignment
- Gutter debris and displaced slate accumulation

Chimney components and base seals should be reviewed by a competent contractor and adjusted or replaced where required.

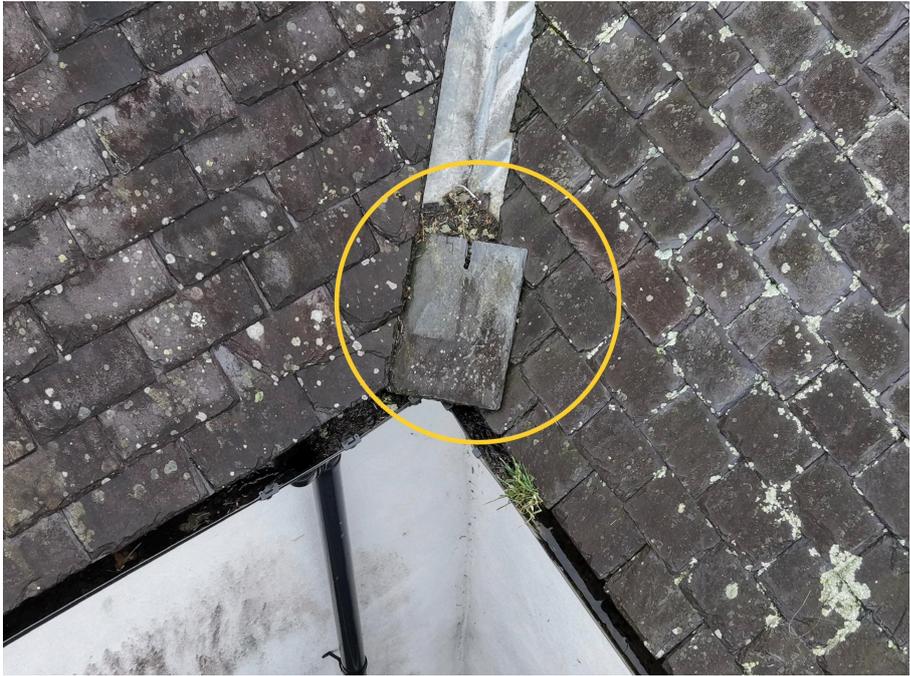
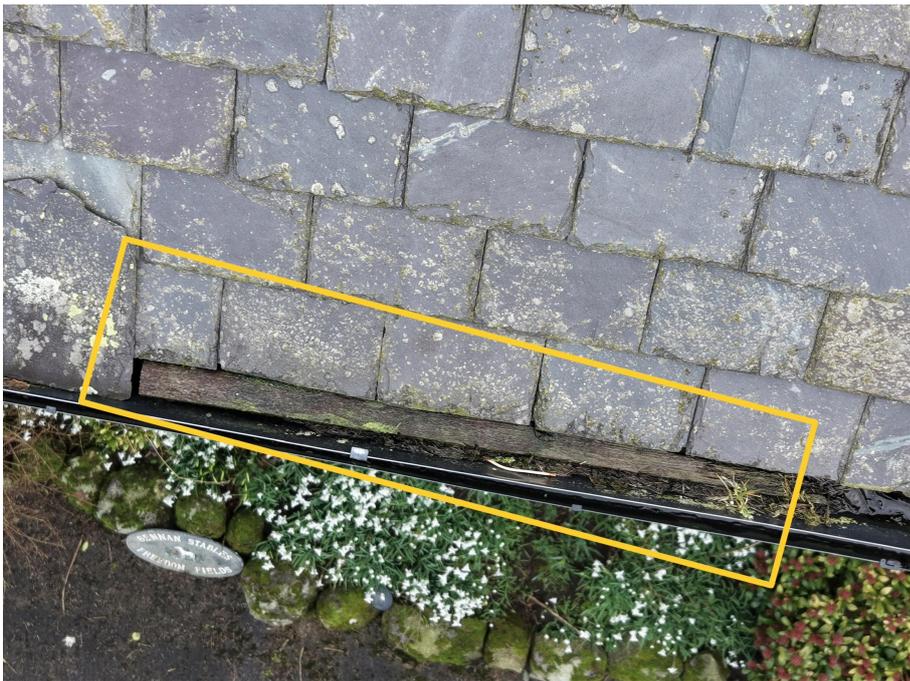
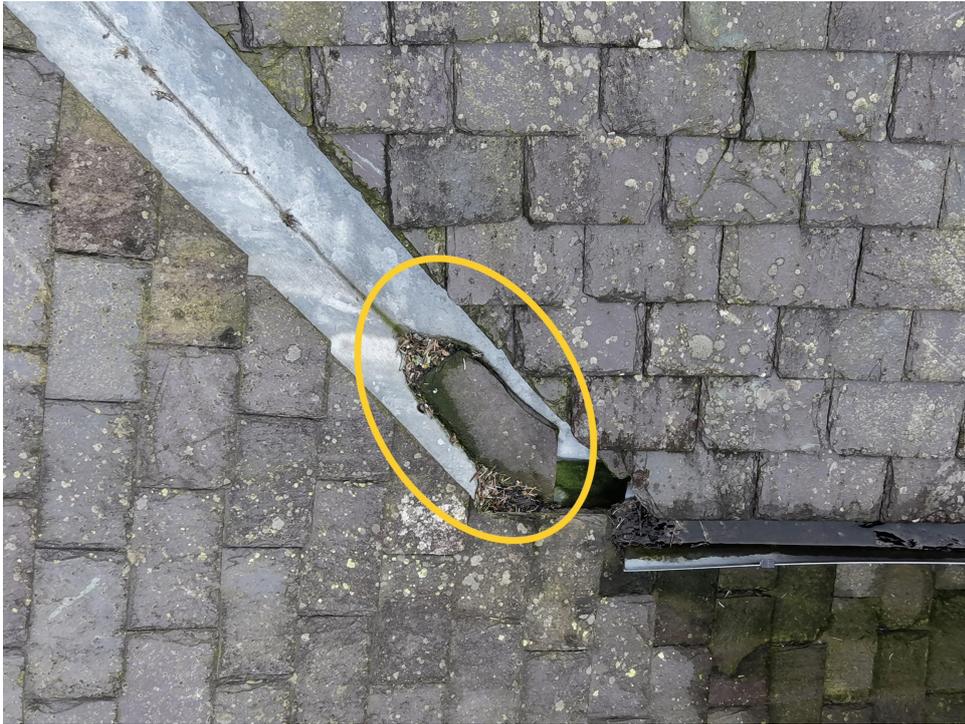
Finding 4 – Gutter Debris and Slate Accumulation

Debris accumulation, including wood fragments, moss, and displaced roof slates, was observed within multiple sections of the guttering system.

Blocked gutters may restrict water flow and lead to overflow during rainfall.

Gutters should be cleared and inspected to ensure proper drainage performance.

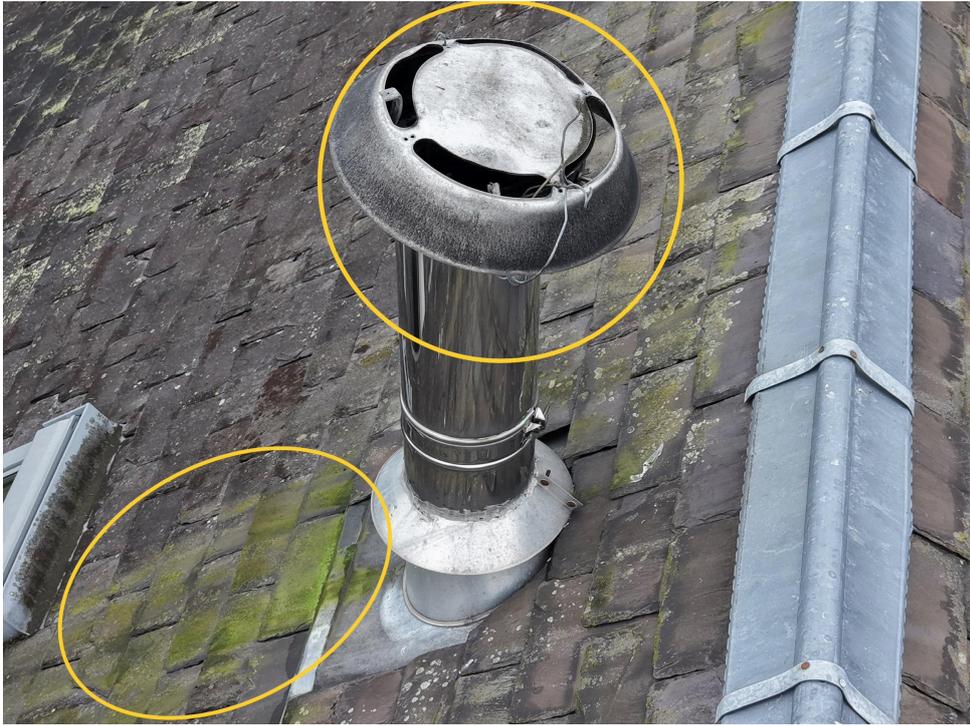
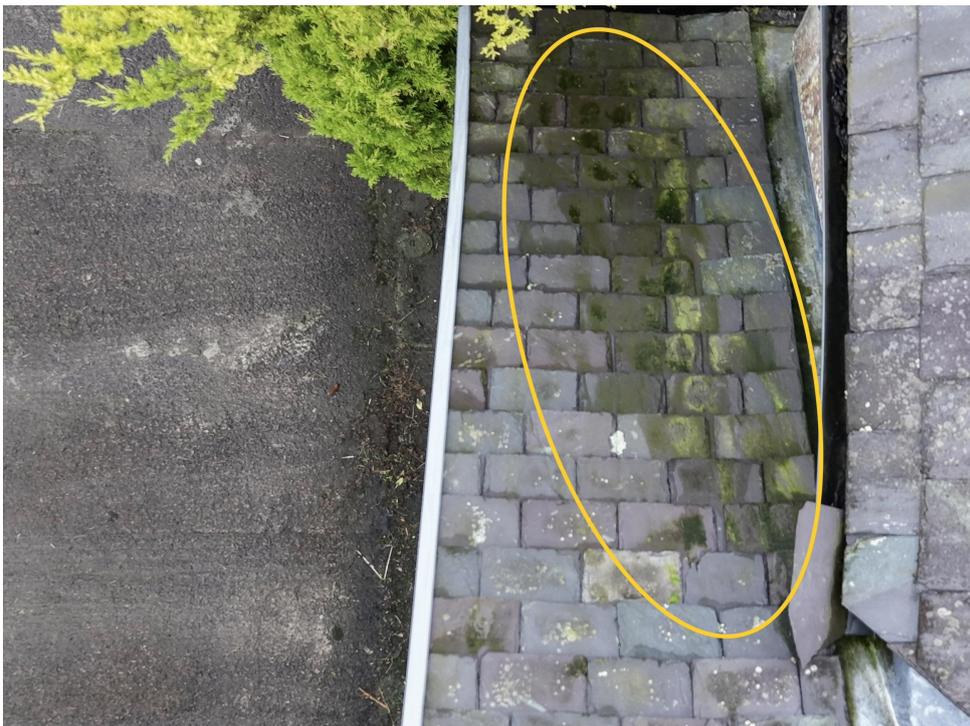
Finding 5 – Moss Accumulation

Moss growth is evident across parts of the roof surface, particularly along shaded elevations and lower courses.

Moss retains moisture and may contribute to gradual surface deterioration over time.

- Moss accumulation

Professional moss removal and preventative treatment may be considered as part of routine maintenance.
